# **APPENDIX B**

## **PHOTOGRAPHS OF THE STANDARD MINE SITE**

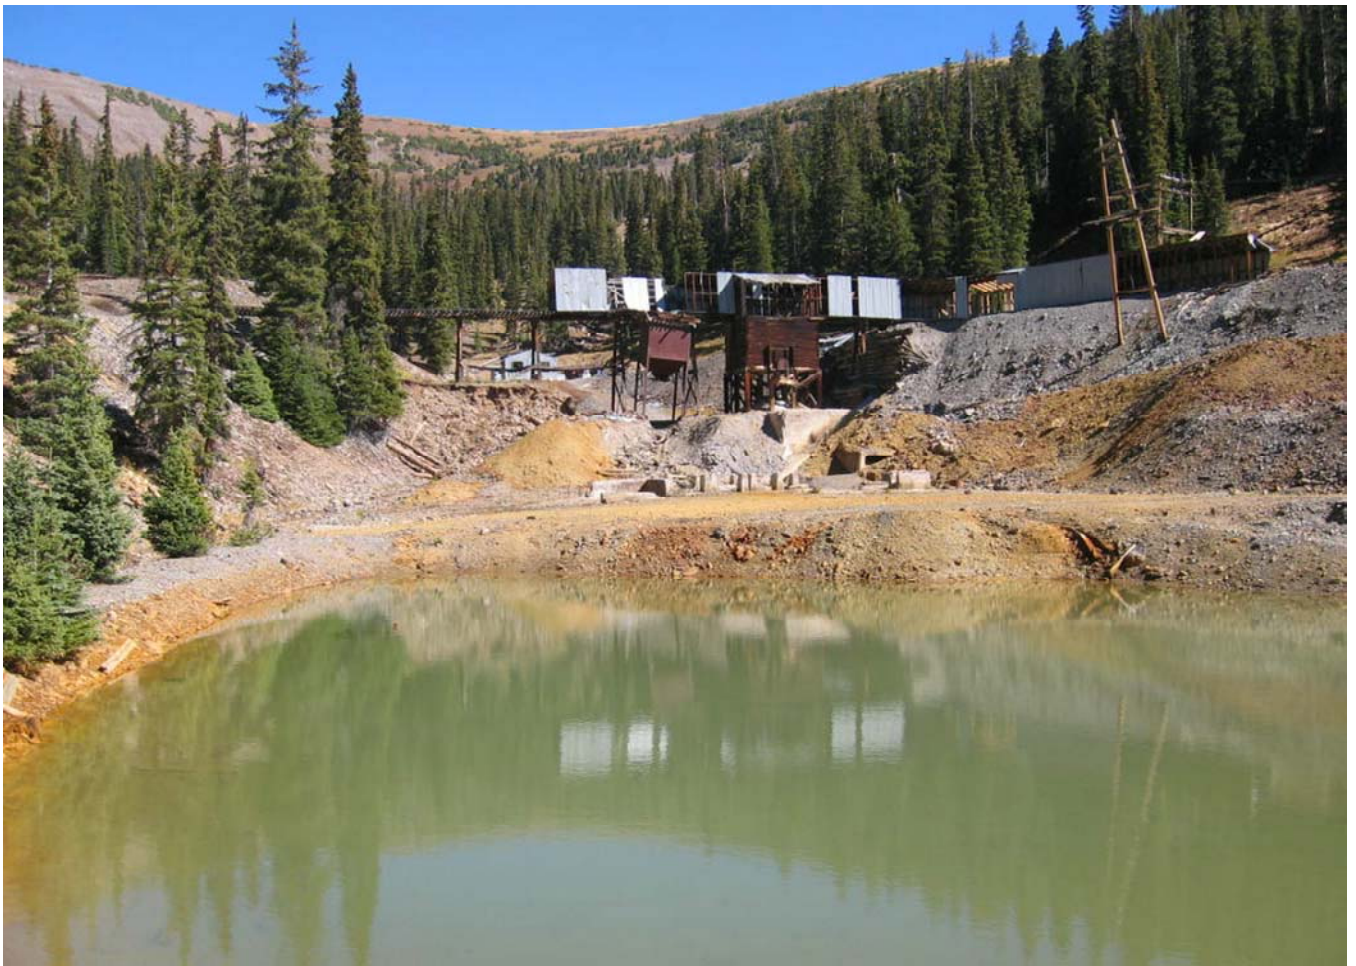
Top: View to the north of Standard Mine. The tailings pond is in the foreground and the remaining mine structures are in the background.

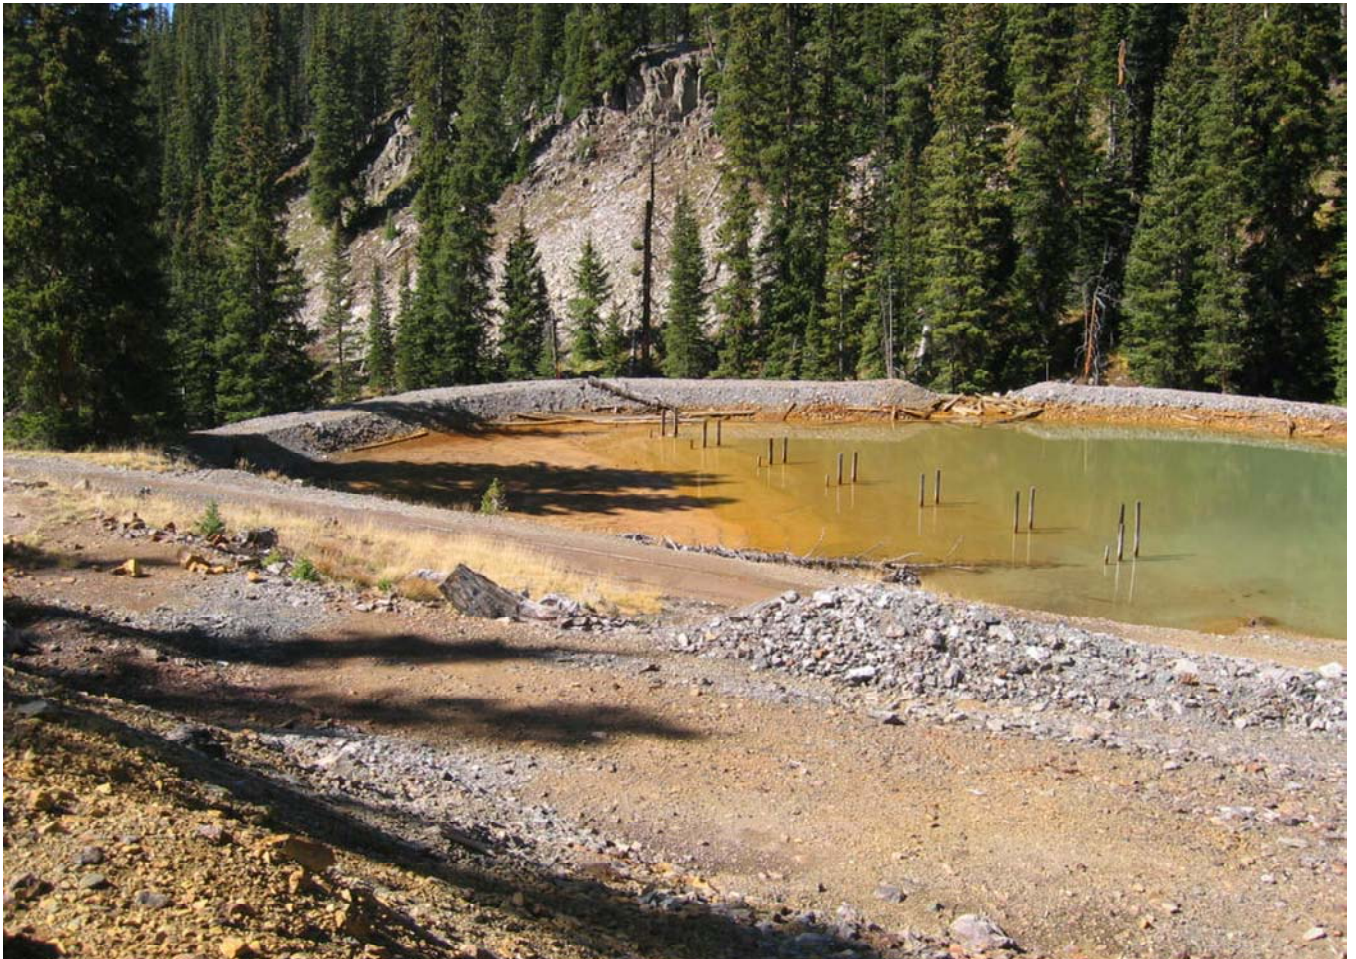
Bottom: View to the southwest of the tailings pond. Note the breach in the tailings dam.

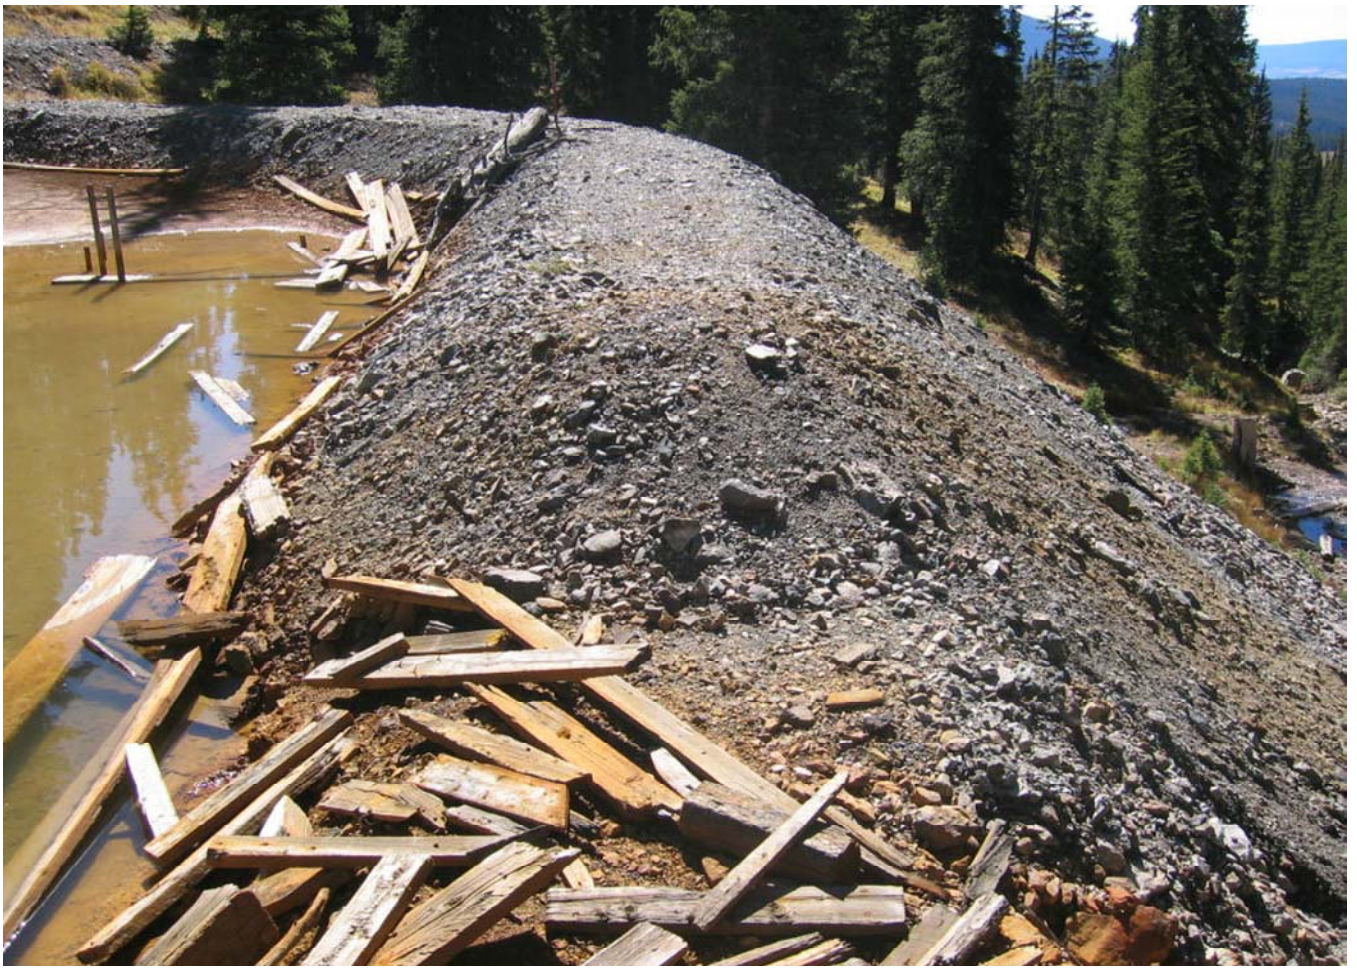
Top: Breach in the tailings dam.

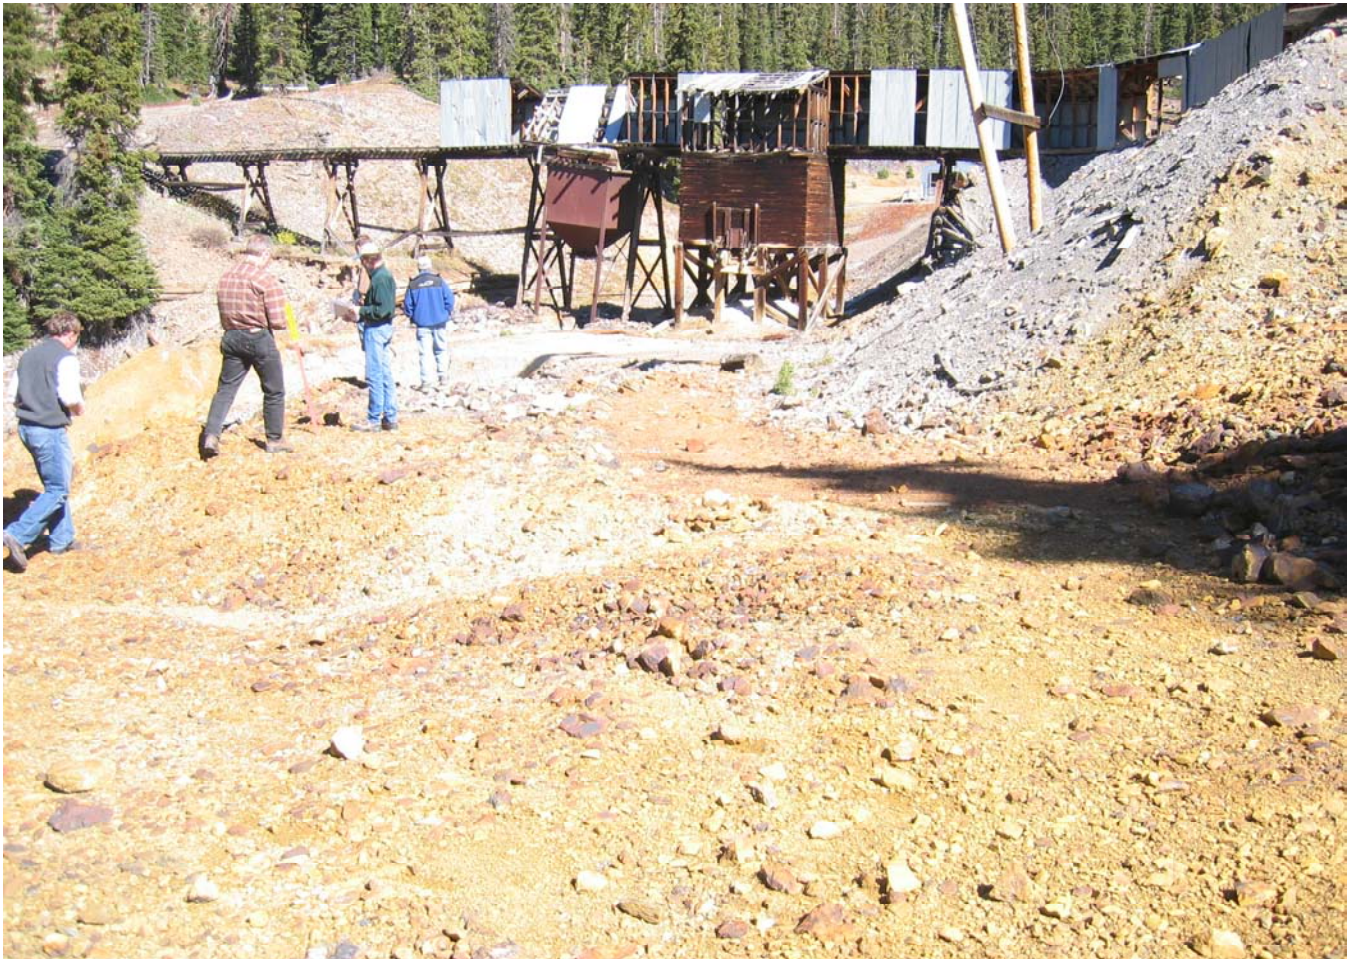
Bottom: View to the north of existing mine buildings. Ore cart rail and associated structures are prominent.

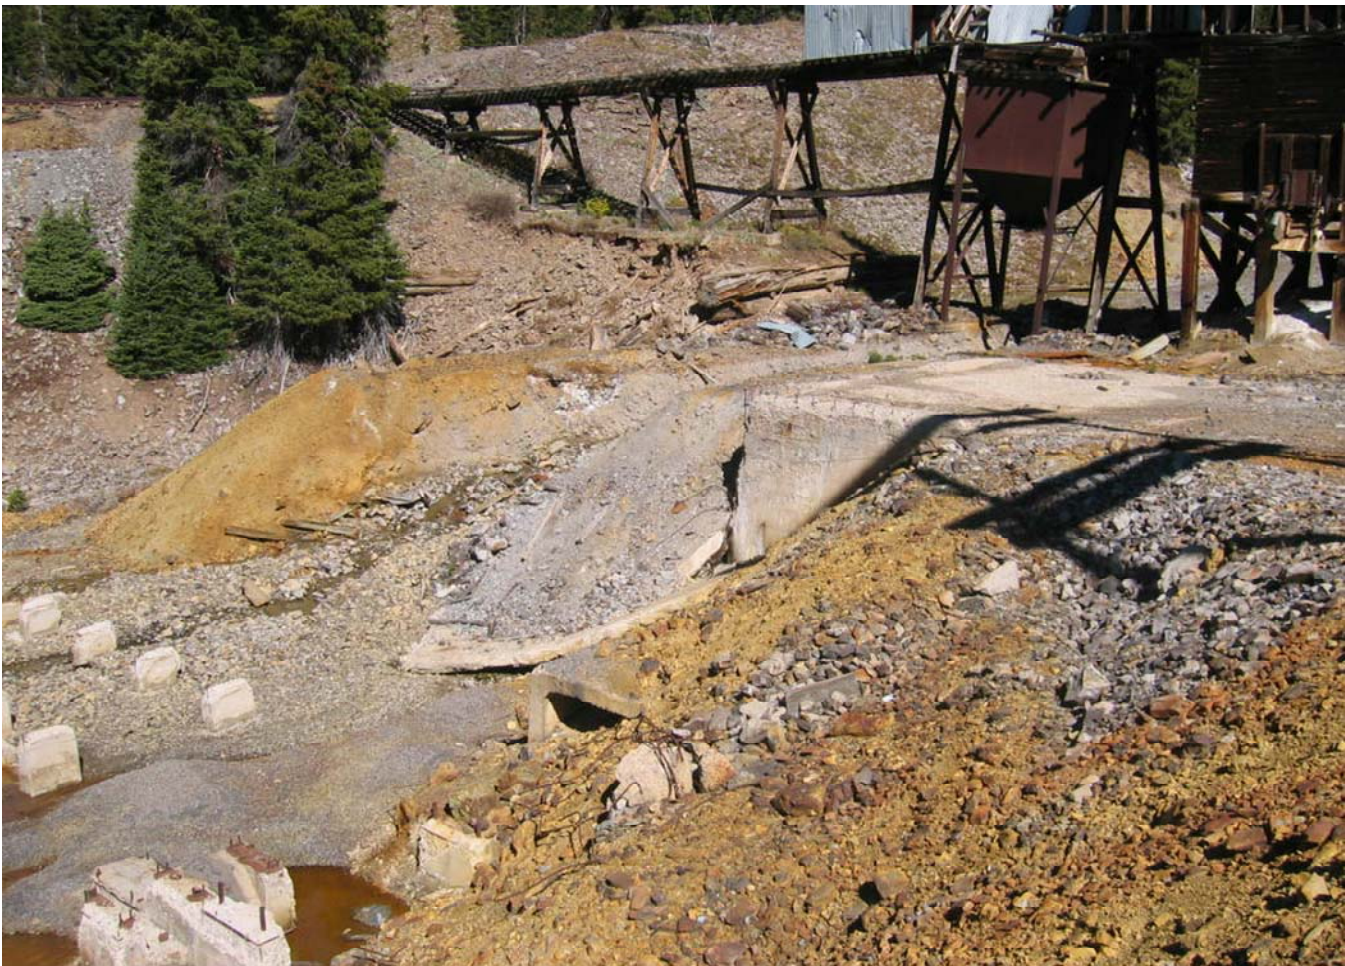
Top: Remaining concrete pad and foundation for mine buildings south of rail structures.

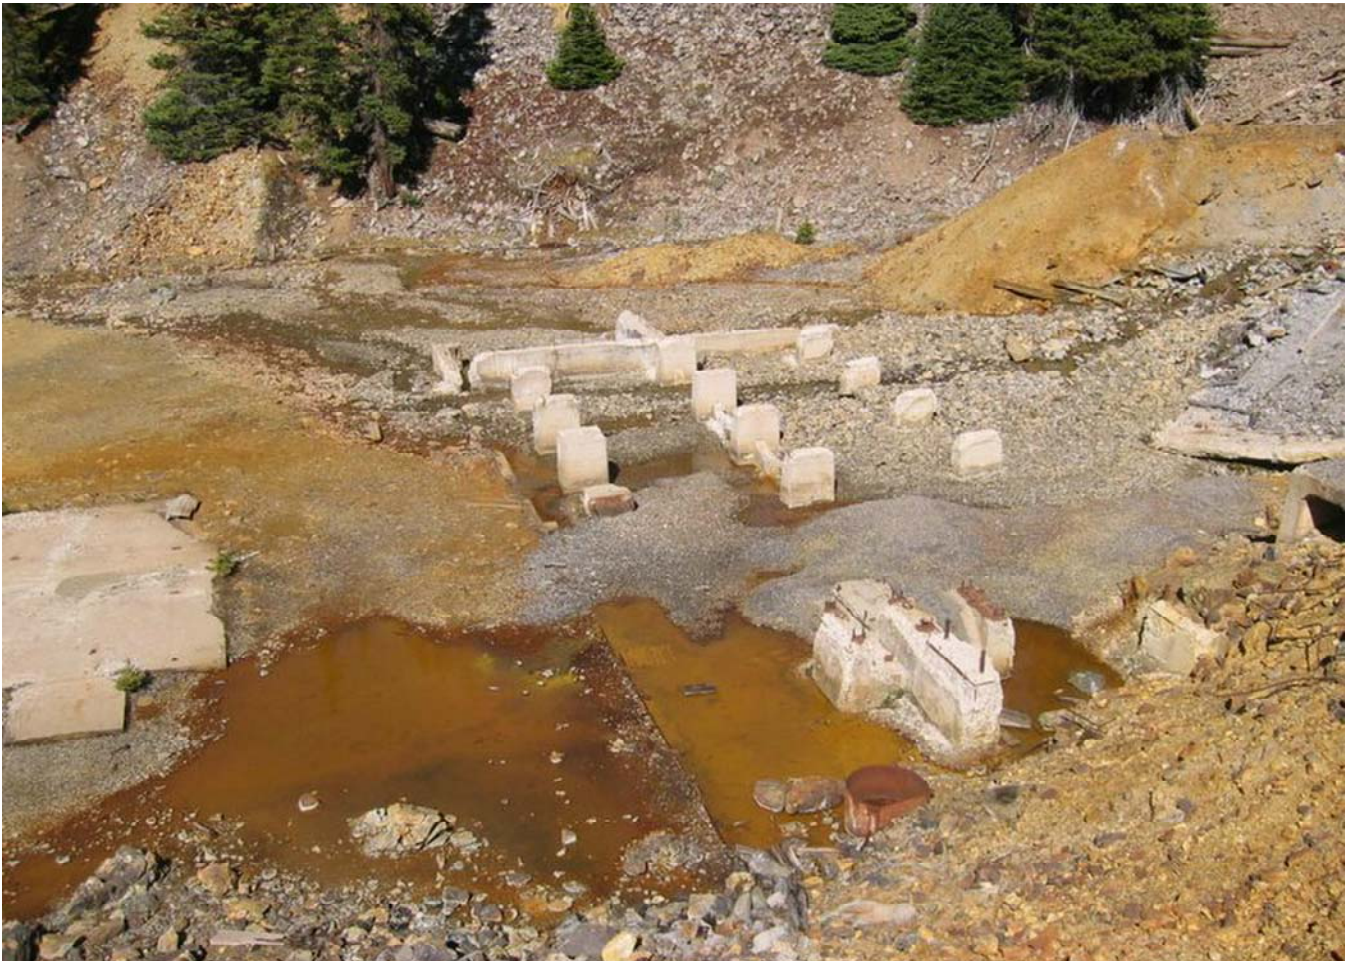
Bottom: Surface drainage from mine area, with Elk Creek flowing along bank in background of the picture.

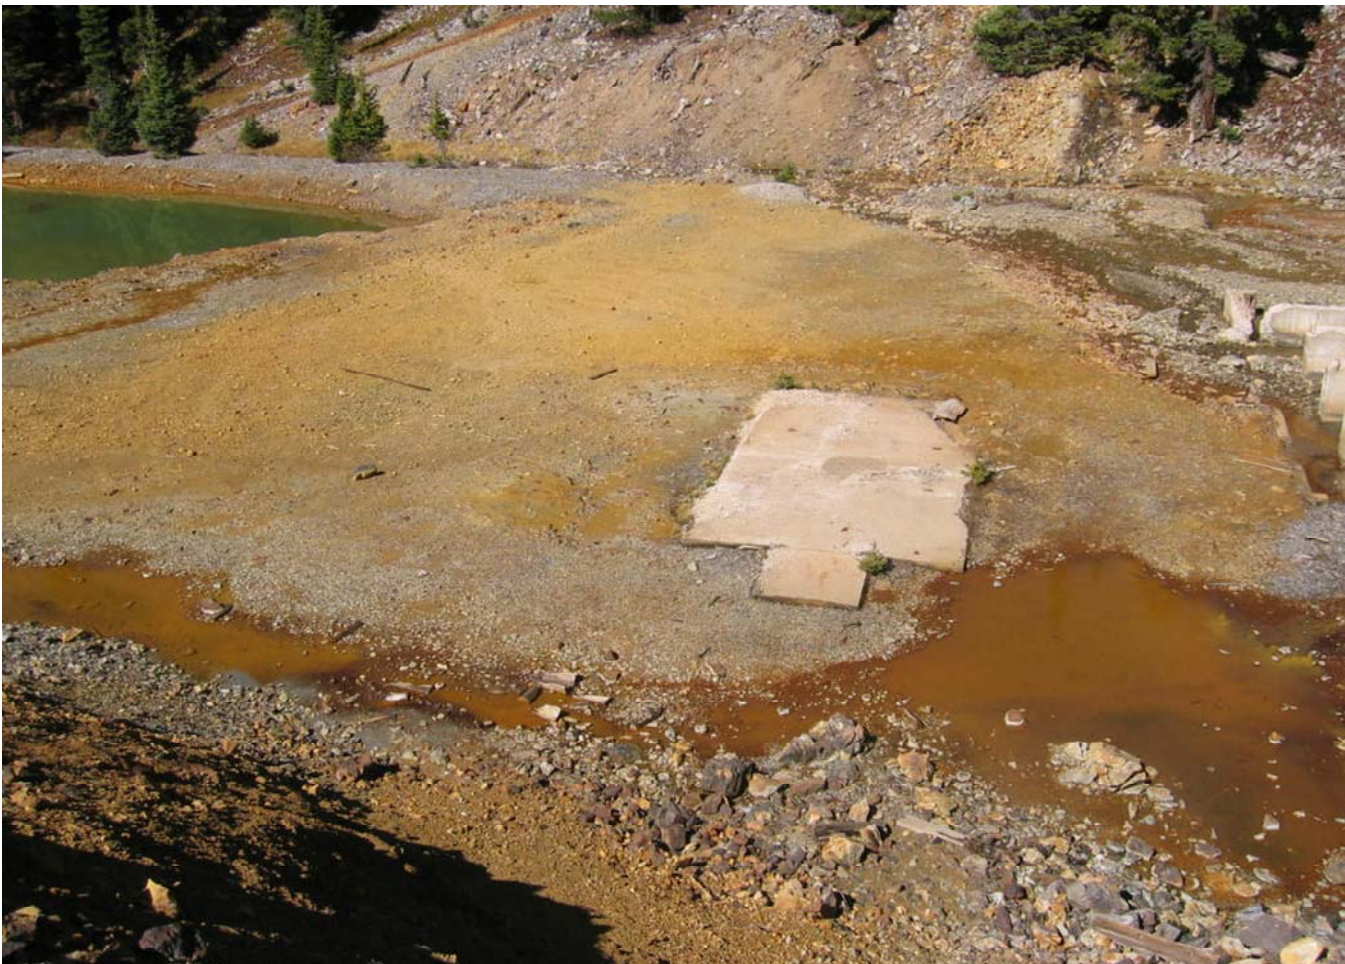
Top: Surface drainage into tailings pond and Elk Creek.

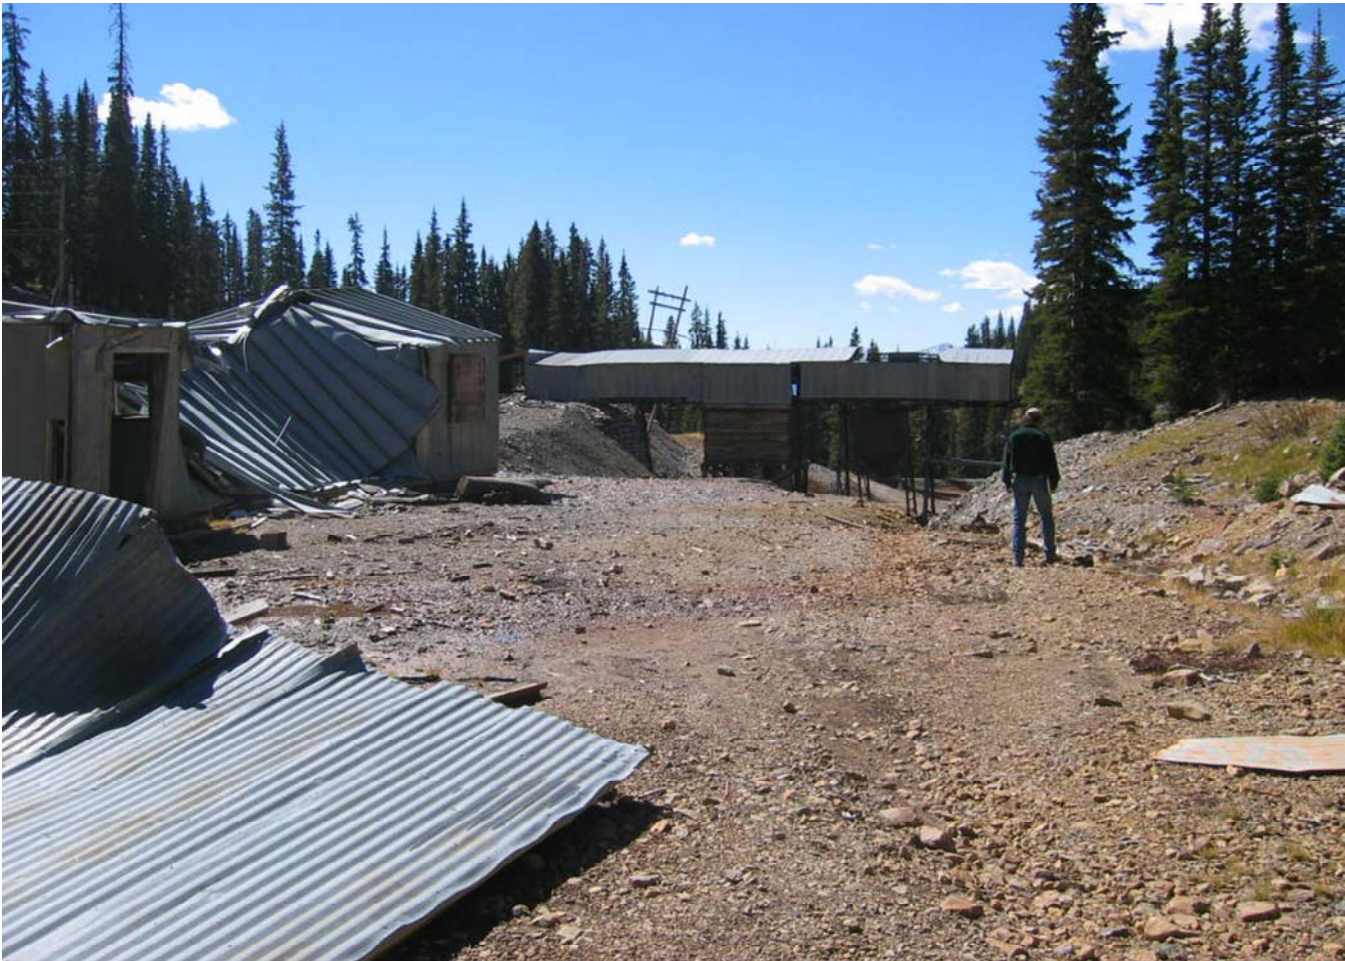
Bottom: View to the south of remaining buildings behind rail structures.

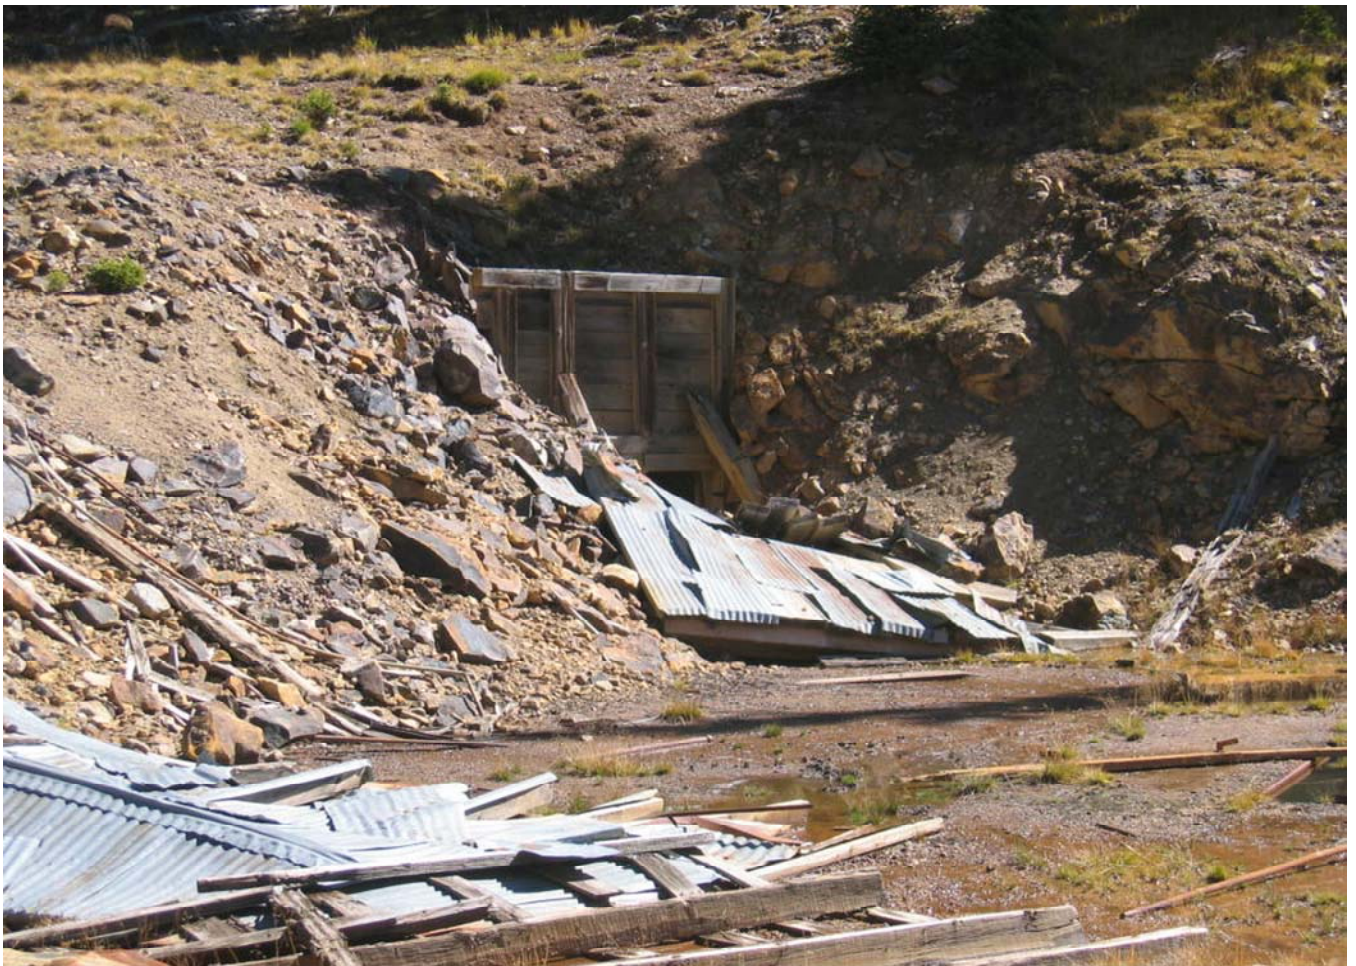
Top: Main adit, or tunnel, for mine.

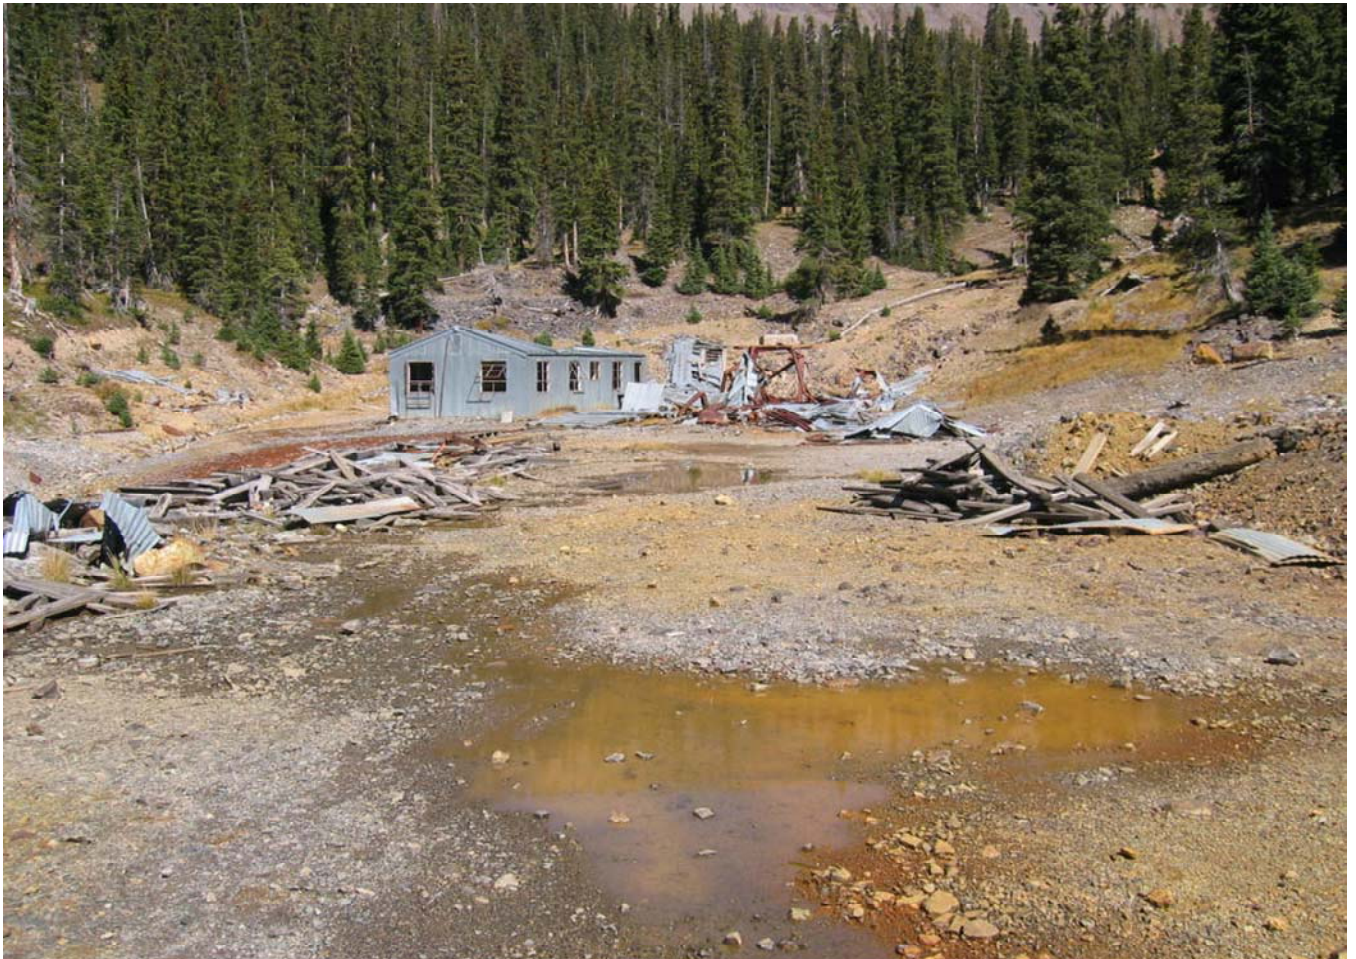
Bottom: View to the north of surface drainage from main adit and abandoned mine buildings.
