# STANDARD MINE UPDATE FACT SHEET

December, 2007

## Standard Mine Background

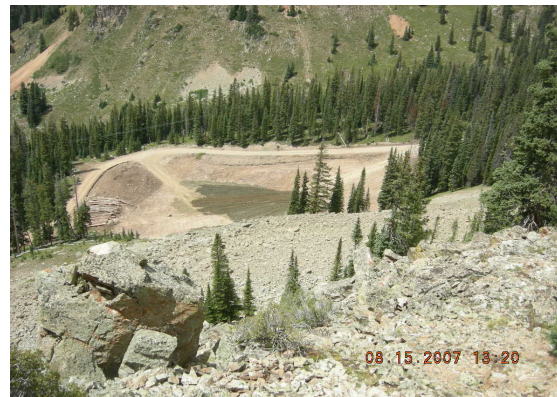
- ◆ **Erosion Control and Continued Road Improvements** — Before any removal of waste rock could occur, EPA installed erosion controls around the tailings impoundment and additional controls were placed along Elk Creek into which diversion ditches flow. Road improvements were implemented as necessary.
- ◆ **Building of the Repository** — Trees were cleared from the selected repository site in preparation for the waste rock and tailings.

Marketable logs were stacked for the U.S. Forest Service, which intends to sell the logs. Smaller trees and limbs were

chipped to be used in the bioreactor and restoration of excavated areas. The top soil was salvaged for later use in site reclamation.

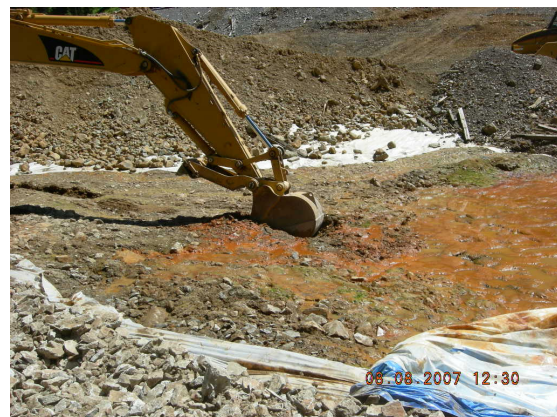
- ◆ **Removal of Waste Rock and Tailings Pond** — The tailings pond and waste rock piles from the mine area were excavated and material was hauled to the repository.

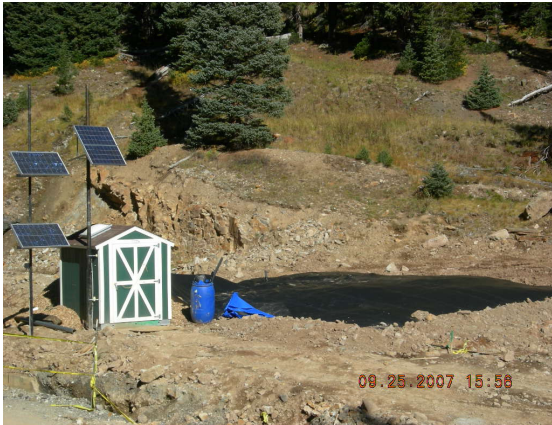
- ◆ **Installation of the Passive Treatment Pilot Scale Bioreactor** — A sulfate-reducing bioreactor pilot study was installed at the mine to determine if this type of passive water treatment is effective

at the mine's high elevation and cold winter climate. This pilot study is scheduled to run throughout the winter and next summer.

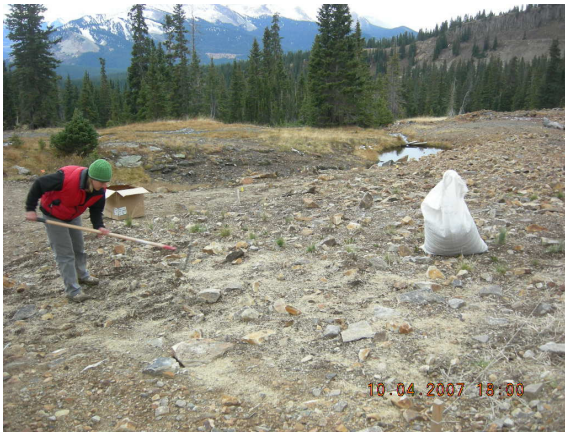
- ◆ **Revegetation Pilot Study** — Five revegetation test plots were installed at Level 98 located above the mine site area. The revegetation will help to determine successful methods for establishing vegetation within the excavated areas and

support reclamation efforts to be implemented at a later time. Lime, compost, and fertilizer were used at varying application rates. Barley seeds and native seeds, which were collected from neighboring areas identified by the USFS, were transplanted into the test areas.
